Community Mobility Plan

September 3, 2021

TDOT Rural Planning Initiative (RuPI) Grant Program

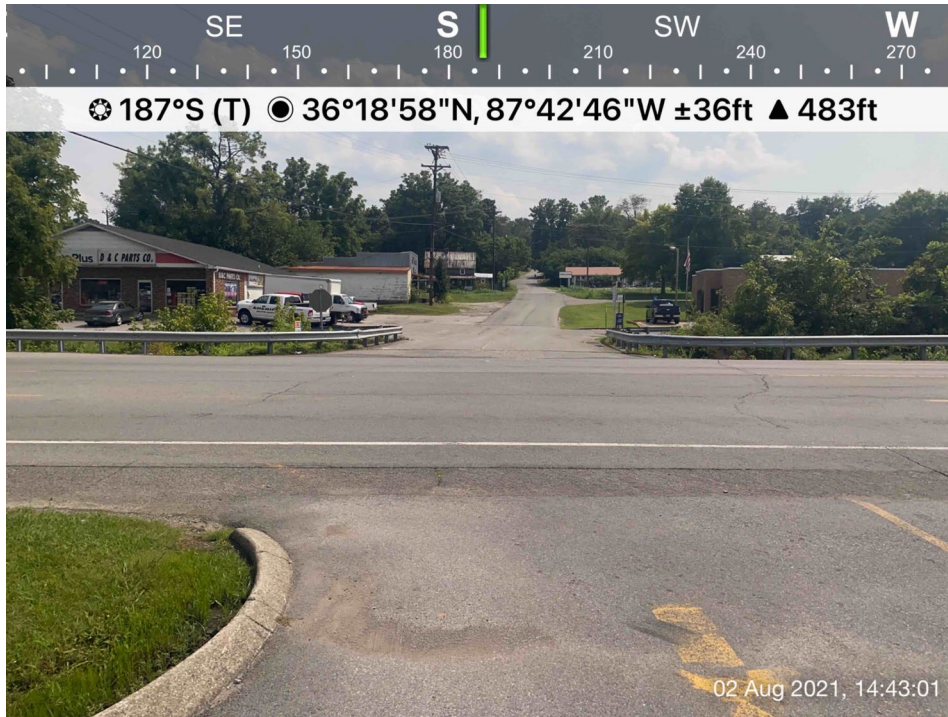
Figure: View of Arlington Ridge Road and bridge, across SR-49 from Piggly Wiggly

rural arterial road with a width of 41 feet (according to field measurement, edge of pavement to edge of pavement), and Arlington Ridge Road, a rural local road with a measured width of 30 feet. Currently, there are no separate pedestrian facilities along Arlington Ridge Road or SR-49 near this intersection, and

pedestrians have been observed walking up Arlington Ridge Road from the south and proceeding across SR-49 at an unmarked and uncontrolled crossing.

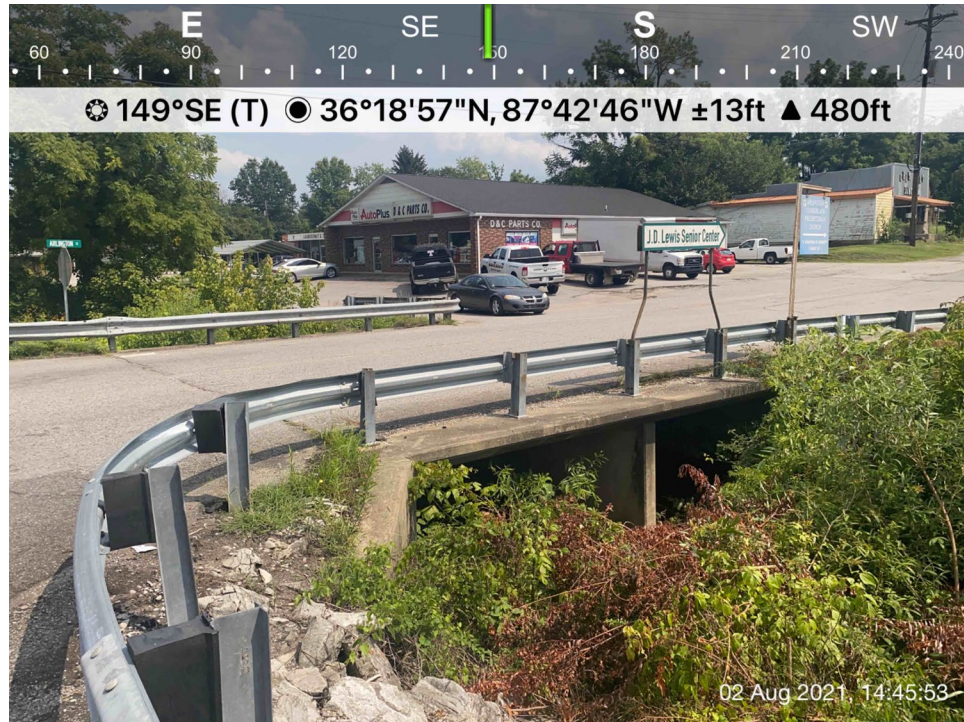
Figure: View of bridge from southern ROW of SR-49, west side of T-intersection

The bridge across Erin Branch Creek poses a special challenge. Fieldwork performed for this report found the width of roadway across the bridge to be 30 feet. FHWA has noted that

retrofitting pedestrian facilities on an existing bridge can be challenging if the bridge cannot be widened, and a bridge is “too narrow to be of value” for installing pedestrian facilities if the width is 26 feet or less.¹¹ The existing bridge is very close to this threshold, which limits opportunities to install pedestrian

facilities at its current width. Furthermore, turning movements for large, multi-axle vehicles are hampered by the close proximity of the bridge to the highway. For vehicles traveling east on SR-49, the acute angle of the intersection of Arlington Ridge Road with SR-49 also makes it difficult to make a right-turn onto the bridge. Additional challenges include:

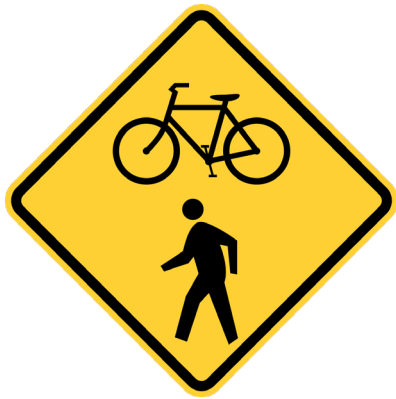
Figure: MUTCD W11-15 sign

AASHTO raises the possibility of using an advance warning assembly (MUTCD W11-15) as a way to warn vehicular drivers of the shared-use path crossing; MUTCD Section 9B-18 provides similar consideration for using W11-15 at the intersection of a shared-use path.¹⁹ It is recommended that, if the abovementioned sidewalk improvements are made, the designer should determine if any pavement marking and signage are required where the Walking Trail intersects with and crosses Arlington Ridge Road.

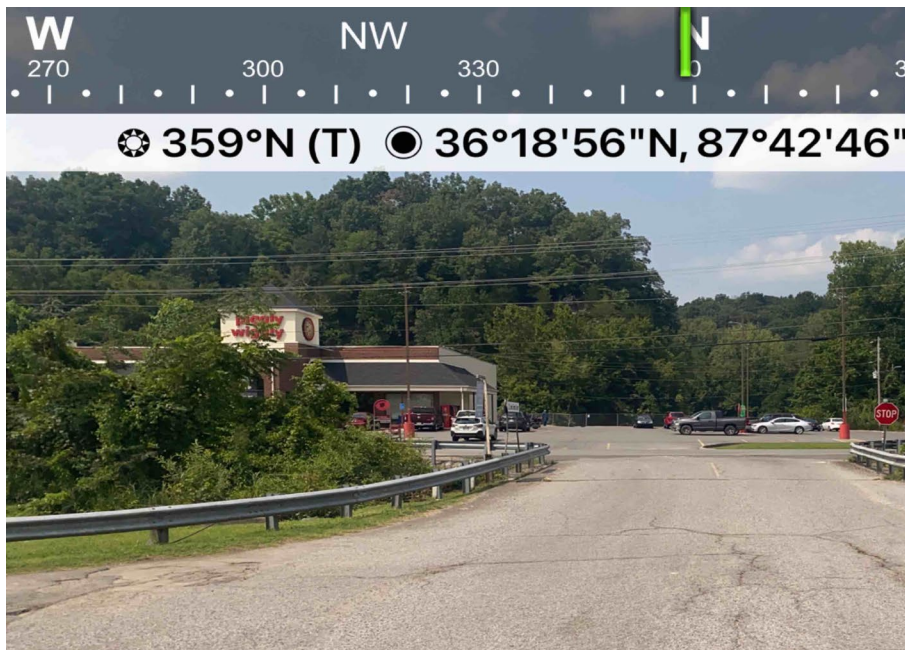
Figure: Brush overgrowth obscuring visibility of SR-49 from Arlington Ridge Rd.

overgrowth within the creek area was making visibility difficult on the western side of the Arlington Ridge Road bridge, directly in front of the U.S. Post Office. This brush overgrowth was confirmed during field visits and appears to make pedestrians and vehicles on the bridge less visible to motorists on SR-49,

bridge. This report recommends looking into options for getting this overgrowth trimmed or cleared, to whatever extent is allowable under applicable laws, including regulations of the Tennessee Department of Environment and Conservation.

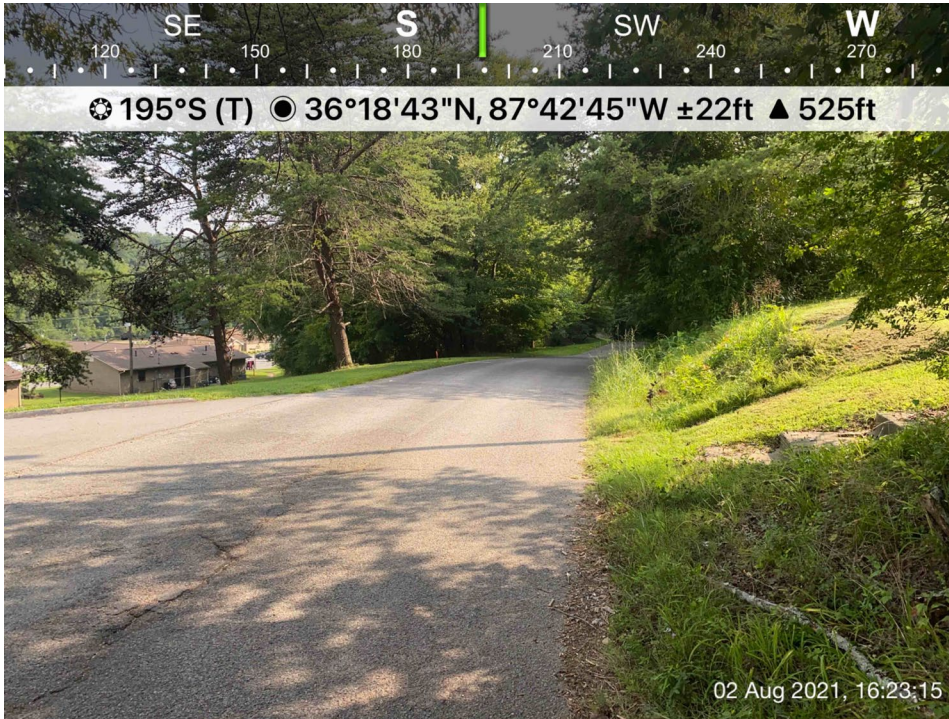
Figure: Knight Street, at Nursing Home entrance

Fieldwork performed for the report found that, adjacent to the Erin Housing Authority, a portion of Knight Street had a width of 17 feet, which is lower than the minimum 18-foot width (9-foot lanes) noted by TDOT as being acceptable for a low-volume rural road requiring multimodal accommodation;²¹ other portions of Knight Street had a width of 18 feet.

In a number of locations along Knight Street, trees, mailboxes, and other vertical obstructions were observed lying only a few feet from the edge of pavement. Given the narrowness of Knight Street and obstructions lying near to the edge of pavement, the street itself appears to be

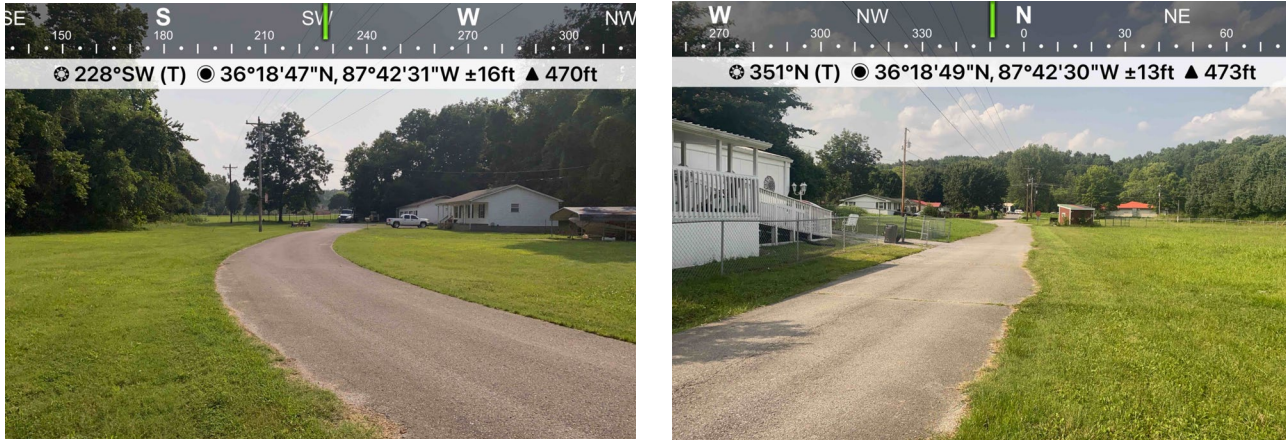
Figure: Roby Lane, looking toward Nursing Home and Erin Housing Authority; looking toward fairgrounds area

Challenges include the narrowness of the existing Roby Lane (15-foot roadway width) and obstructions lying relatively close to the edge of pavement (e.g. ticket box at the fairgrounds and an electric pole lying less than 8 feet from edge of pavement; private chainlink fence gate lies at edge of pavement). The City, Erin Housing Authority, and Nursing Home should discuss options for allowing Erin Housing Authority residents to cross property owned by the Nursing Home, whether over the City's sewer easement or a pathway installed in conjunction with future Nursing Home development.

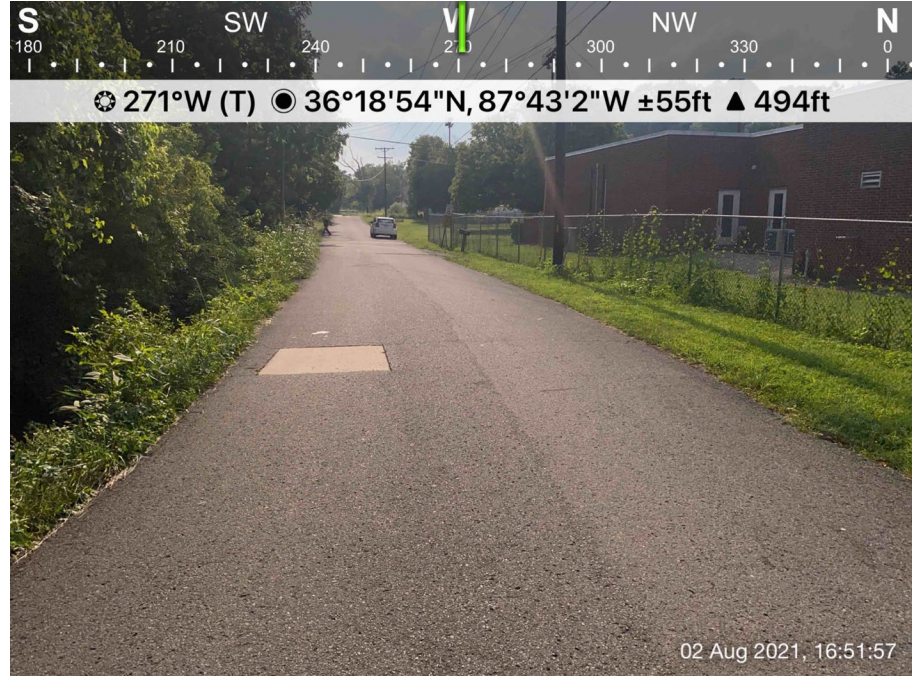
Figure: McMillian street (16-foot width) adjacent to Middle School

McMillian Street is very narrow (16-feet in width, by field measurement) at the point where it runs adjacent to the Houston County Middle School, being constrained in width by electric

poles and fences on the northern margin and a creek on the southern margin. The narrowness of McMillian Street in this area effectively makes it a yield roadway, serving traffic in both directions without lane markings, with limited width and natural stormwater management.²⁴ FHWA advises that preferred vehicular volume should

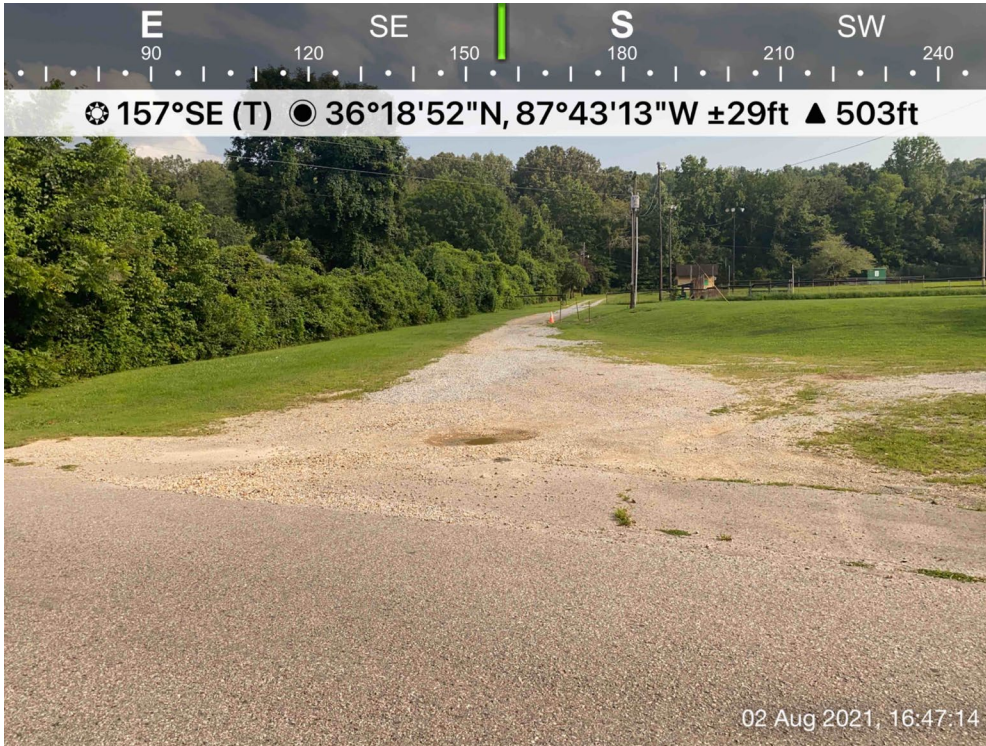
Figure: Existing gravel drive adjacent to ballfield, looking from McMillian St.

Sidewalk Connecting Walking Trail Extension to Ballfields and Middle School: FHWA has noted that it is preferred that school connections be designed with "as much separation as possible" between children and vehicles, with sidewalk installation preferred over using road shoulders.³⁴ This high-level of separation appears to be feasible if children coming to school

from the south and east are routed along the extended Walking Trail instead of walking on the right-of-way of McMillian Street; children would be routed westward down the extension of the Walking Trail and then northward along a new sidewalk facility

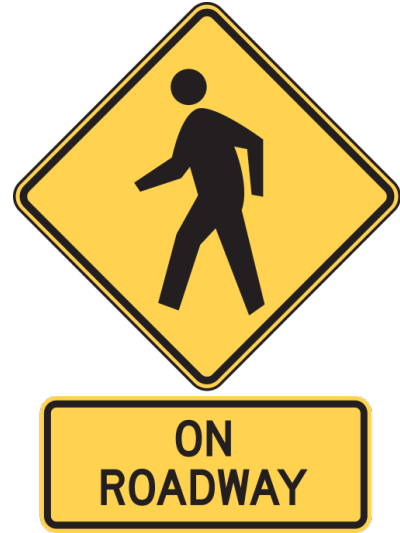
Figure: MUTCD W11-2 with legend plaque

Pedestrian Signage on McMillian Street: Given that pedestrians might walk down McMillian Street in the area adjacent to the Middle School, the City could consider putting up a

pedestrian warning sign (MUTCD W11-2) with an “on roadway” legend plaque. Currently, “Children at Play” signs accompany the 15 mph speed limit signs, but there are not any pedestrian-specific signs.

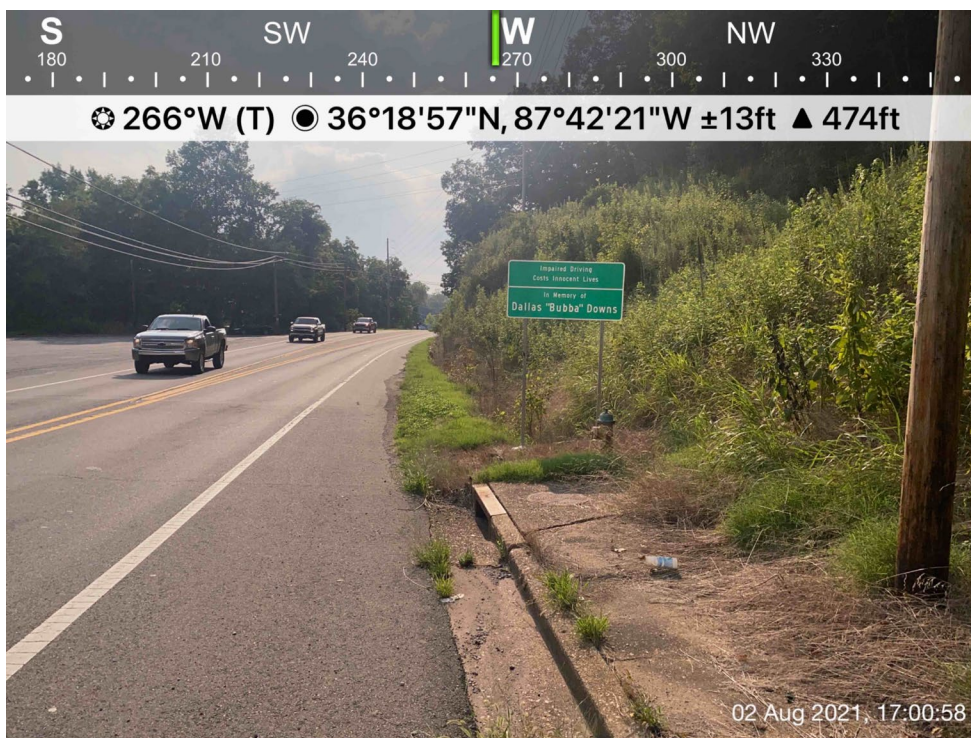
Figure: Terminus of existing sidewalk, northern margin of SR-49

Fieldwork performed for this report showed that the width of existing sidewalk at terminus is 4.5 feet; it appears that the existing sidewalk was installed at 5-foot width but hillside erosion has covered a portion of it. FHWA recommends that a “constrained minimum” sidewalk in a pedestrian through zone should be a minimum of 5-feet in width, which will be wide enough for pedestrians to walk side-by-wide and will meet accessibility requirements for turning movement.³⁸ TDOT’s Roadway Design Guideline provides for a preferred buffer (edge of traveled way to edge of sidewalk) of 5 feet and a minimum buffer of 0 feet for a posted speed less than or equal to 35 mph.³⁹ Further study is required to determine the location of existing right-of-way and whether room exists to install this sidewalk extension without taking adjacent property, which was a concern expressed at the Public Involvement Meeting.

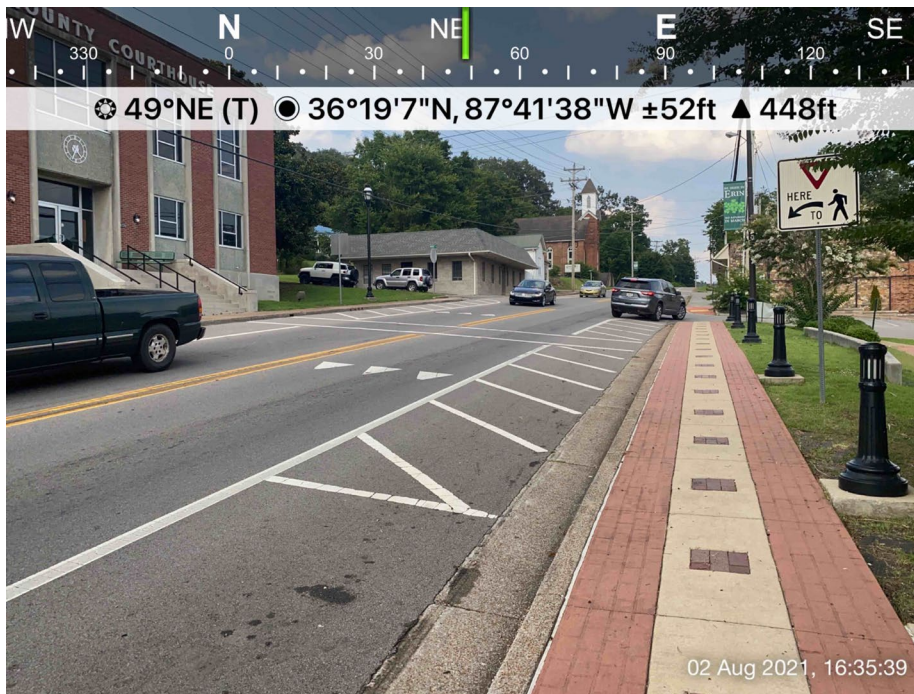
Figure: Existing transverse crosswalk, no-parking area, and pedestrian yield sign.

Overcoming this challenge, the City of Erin was able to install an uncontrolled marked transverse pedestrian crosswalk located midblock between the courthouse square parking area to the south and the Houston County Courthouse to the north. Fieldwork performed for this report indicates that the width

Crosswalk: As noted above, the existing crosswalk is transverse. FHWA has noted that transverse lines are “essentially not visible” from a vehicle approaching the crosswalk from the roadway.⁴⁴

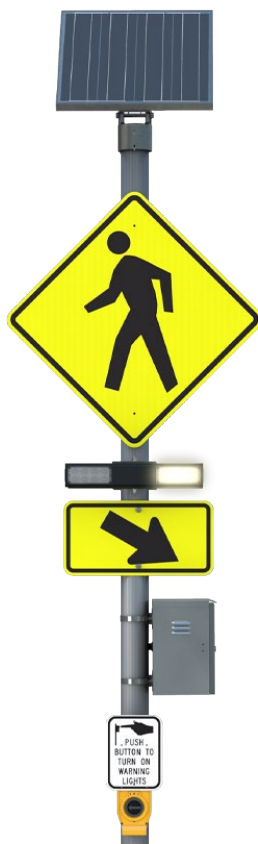
Figure: Solar-powered RRFB example

may be solar-powered depending on cost. An RRFB works by using a flashing light to alert vehicular drivers on the roadway to the presence of pedestrians using the crosswalk.⁵⁰ The lights only flash after a pedestrian manually activates them or a passive detection system activates them.⁵¹ A study by FHWA has found that crossings with a RRFB had an average compliance rate (for vehicles yielding to pedestrians at the crosswalk) of 88 percent, and FHWA has noted that RRFBs are effective at crossings of roadways with a speed limit of 40 mph or less.⁵² Among safety countermeasures, flashing beacons are considered to be in the “high effectiveness” category and “significantly increase[] motorist yielding behavior.”⁵³

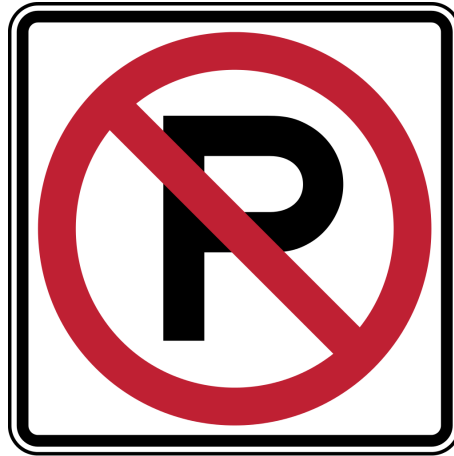
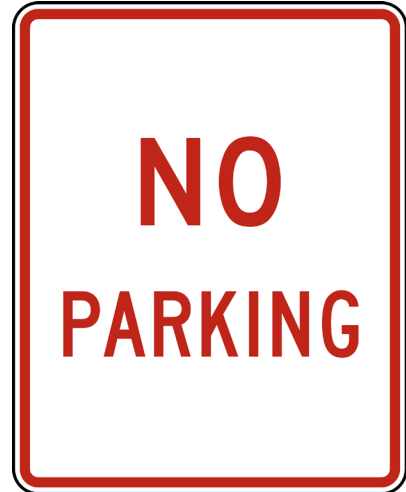
Figure: MUTCD R8-3 (left) and R8-3a (right) signs

pavement itself. This report recommends painting the words “No Parking” within the striped area, or mounting a MUTCD R8-3 or R8-3a sign directly adjacent to the striped area, or both.

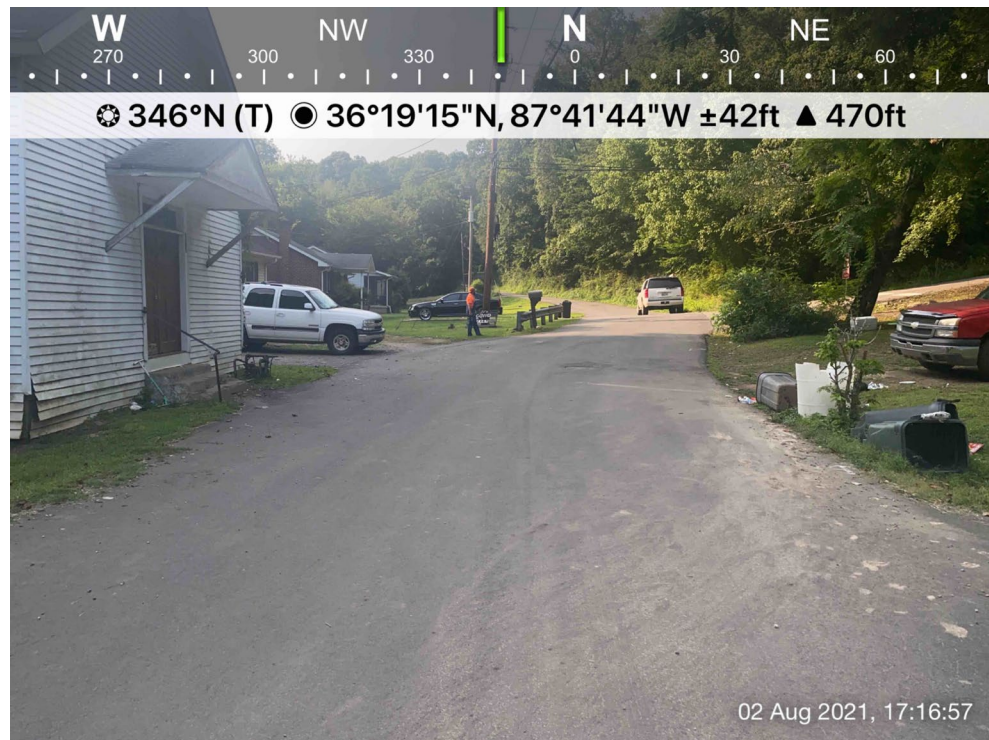
Figure: Spring Street narrows as it approaches East Spring Loop

narrows considerably from the intersection with Walnut Street (approximately 38.75 feet wide by field measurement) to the intersection with East Spring Loop (approximately 25 feet wide by field measurement). Additionally, vertical obstructions and buildings lie relatively close to the existing edge of pavement.

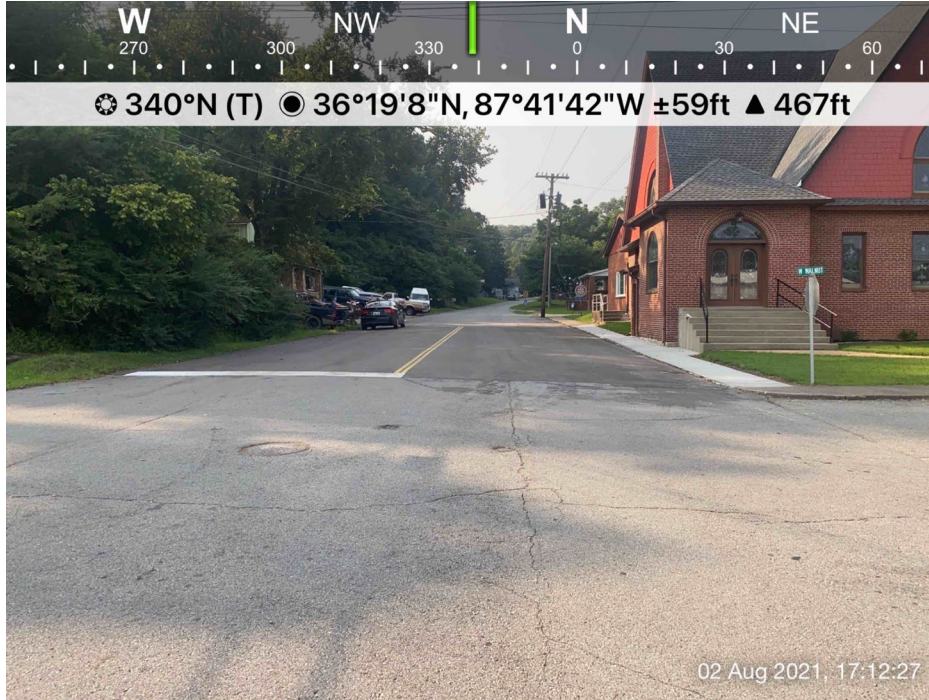
Figure: Intersection of Walnut Street and Spring Street

Sidewalk Extension: Currently, a sidewalk exists at the southwest corner of the intersection of Spring Street and Walnut Street. A transverse crosswalk could be painted across Walnut
